Structerre reference number: S598518/DG

RETAINING WALL at #11B KEBLE HEIGHTS COLLEGE GROVE

1. PURPOSE

The purpose of the visit was to inspect and comment upon the retaining wall built along the left side of the property.

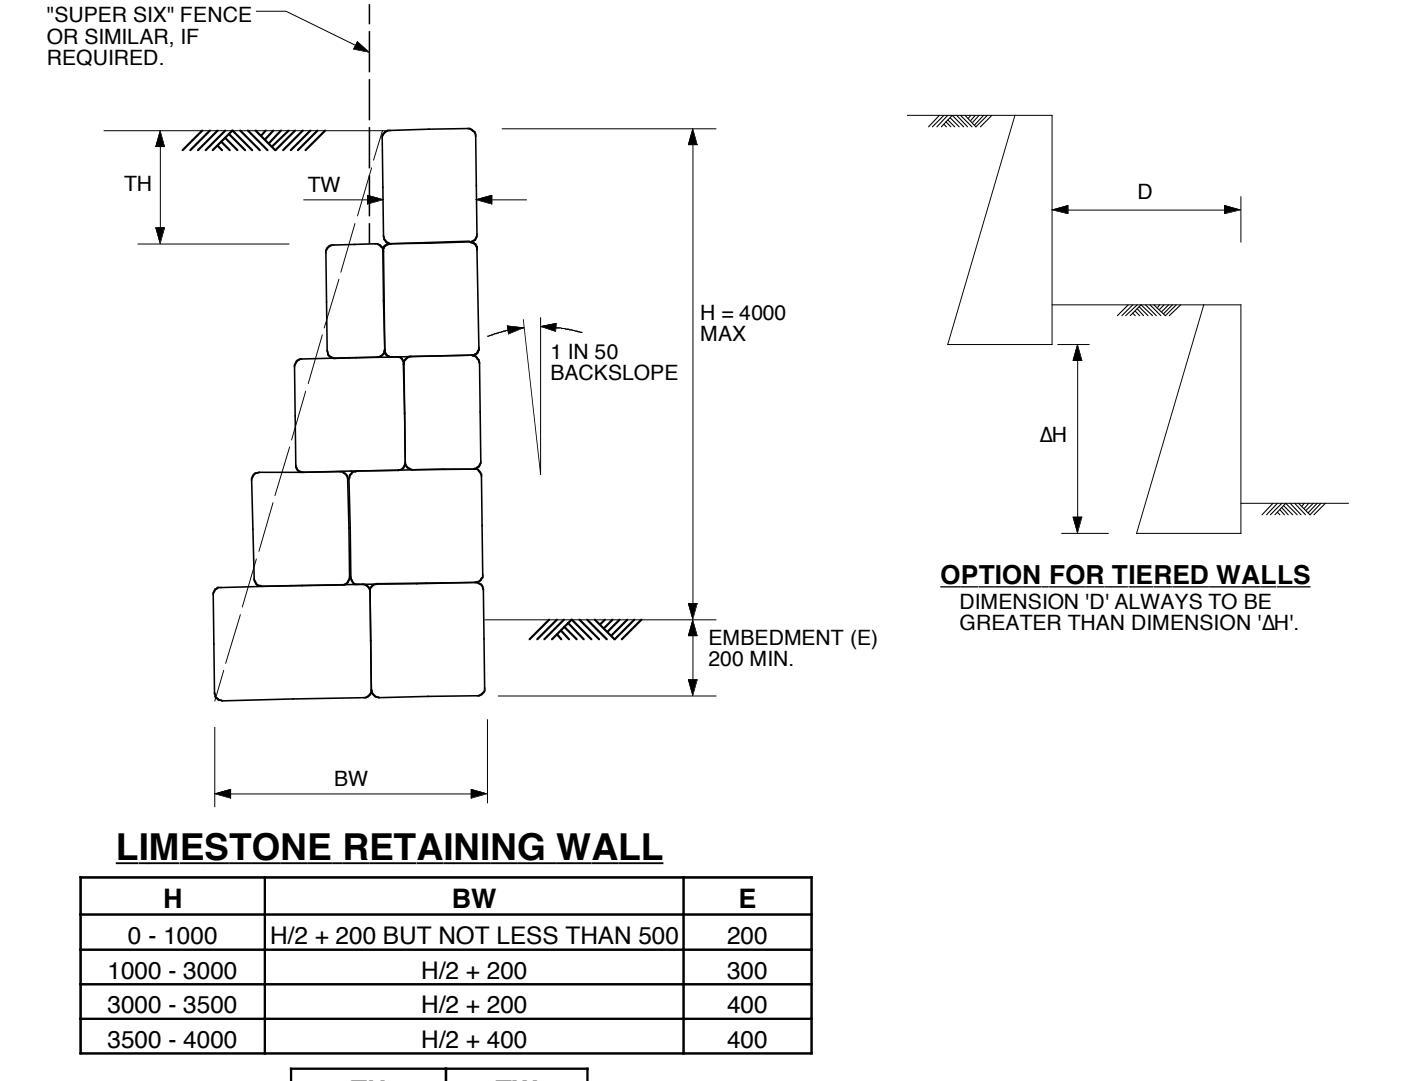
Enclosed: - HOR Detail

It is evident also that the boundary wall has not been constructed with enough backing blocks to meet the Structerre minimum detail as shown in attached HOR Detail. Had it been built to this minimum detail, it still would not guarantee no overturn or failure, as the surcharge loads are in excess of those this detail is capable of restraining. Therefore, partial cause of failure needs to be attributed to this under-design of the wall.
